K/P-6197, Rev. 1

INVESTIGATION OF A URANIUM HEXAFLUORIDE
RELEASE INCIDENT ON SEPTEMBER 17, 1975,
IN THE K-1423 TOLL ENRICHMENT FACILITY

Oak Ridge Gaseous Diffusion Plant

April 16, 1986

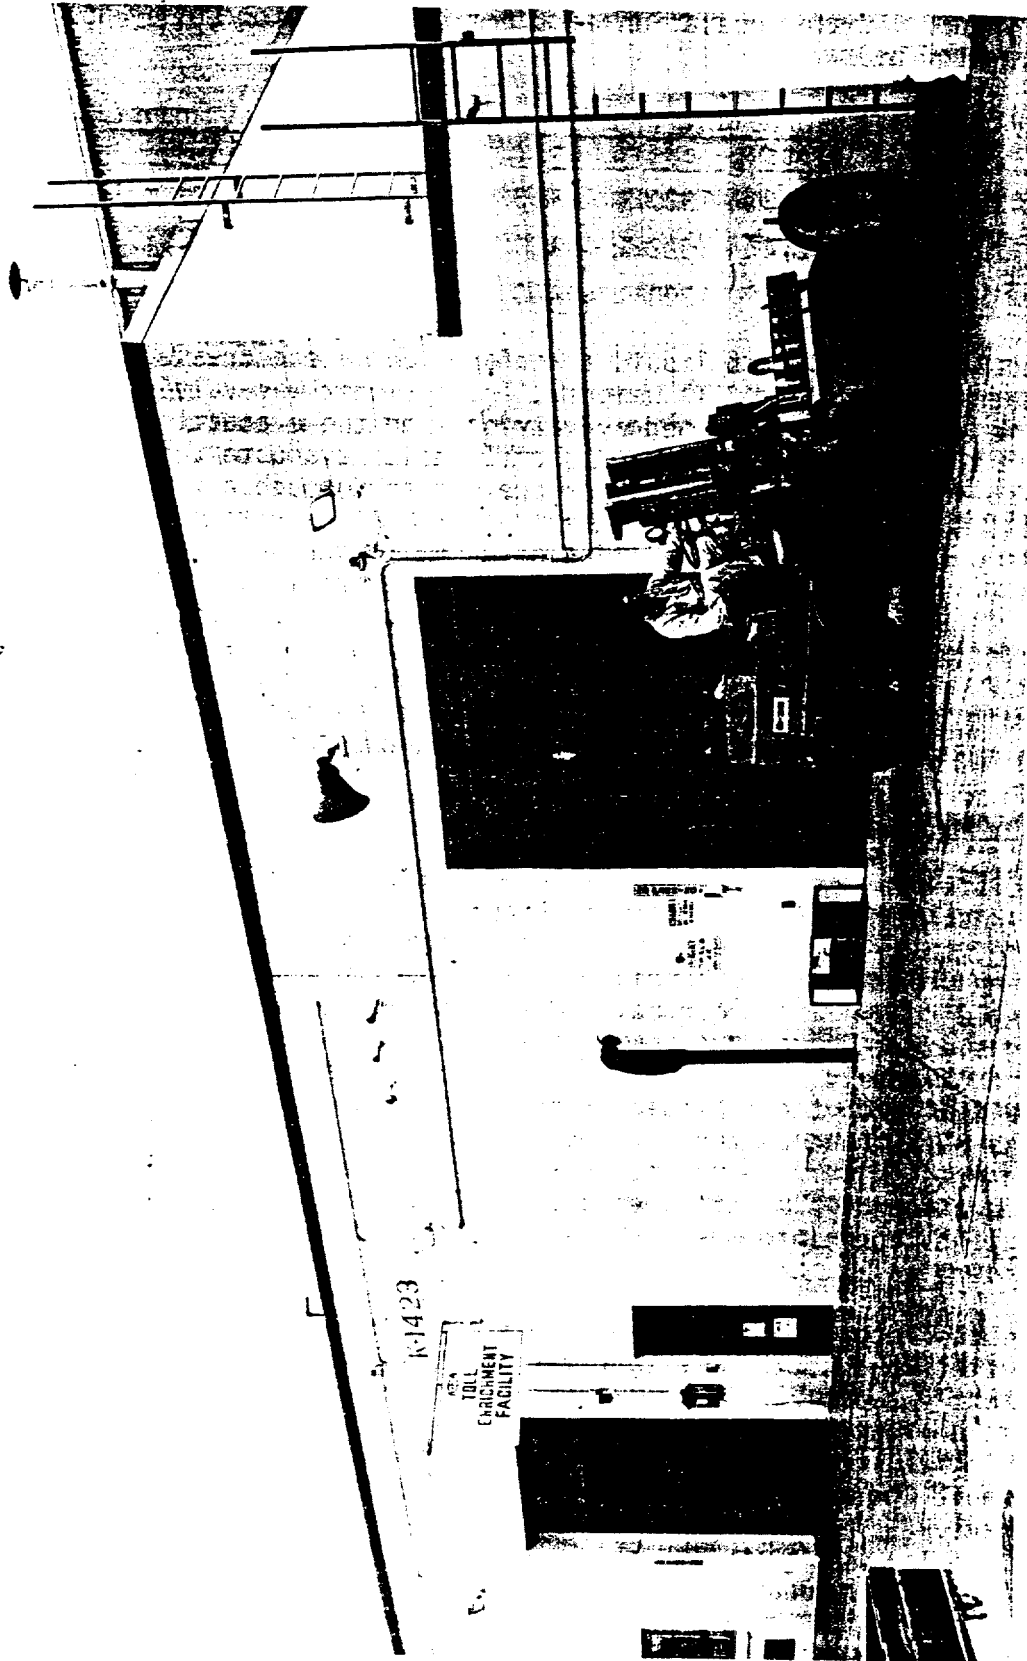
PHOTO NO. 75-3000

Immediately after filling, Cylinder N-8 was moved by forklift to a storage area west of K-1423 for cooling (Figure 2). After the cylinder was lowered to the concrete storage pad, operators **No. 1 and No. 2** proceeded to disengage the lifting fixture hooks from the cylinder. A single loud noise occurred, and the concave ends of the cylinder bulged and gas emerged from a crack in the valve body and a circumferential split of approximately 2 in. in length in the cylinder wall 2-1/2 in. from the opposite end of the cylinder (Figures 3 and 4). Operator **No. 1** was struck in the right hand by the lifting hook as it was propelled away from the cylinder; however, he was not seriously injured. Operator **No. 2** incurred a laceration of his left knee and was knocked to the ground when the metal identification plate was forcibly ejected from the opposite end of the cylinder.

Figure 2
STORAGE AREA WEST SIDE K-1423

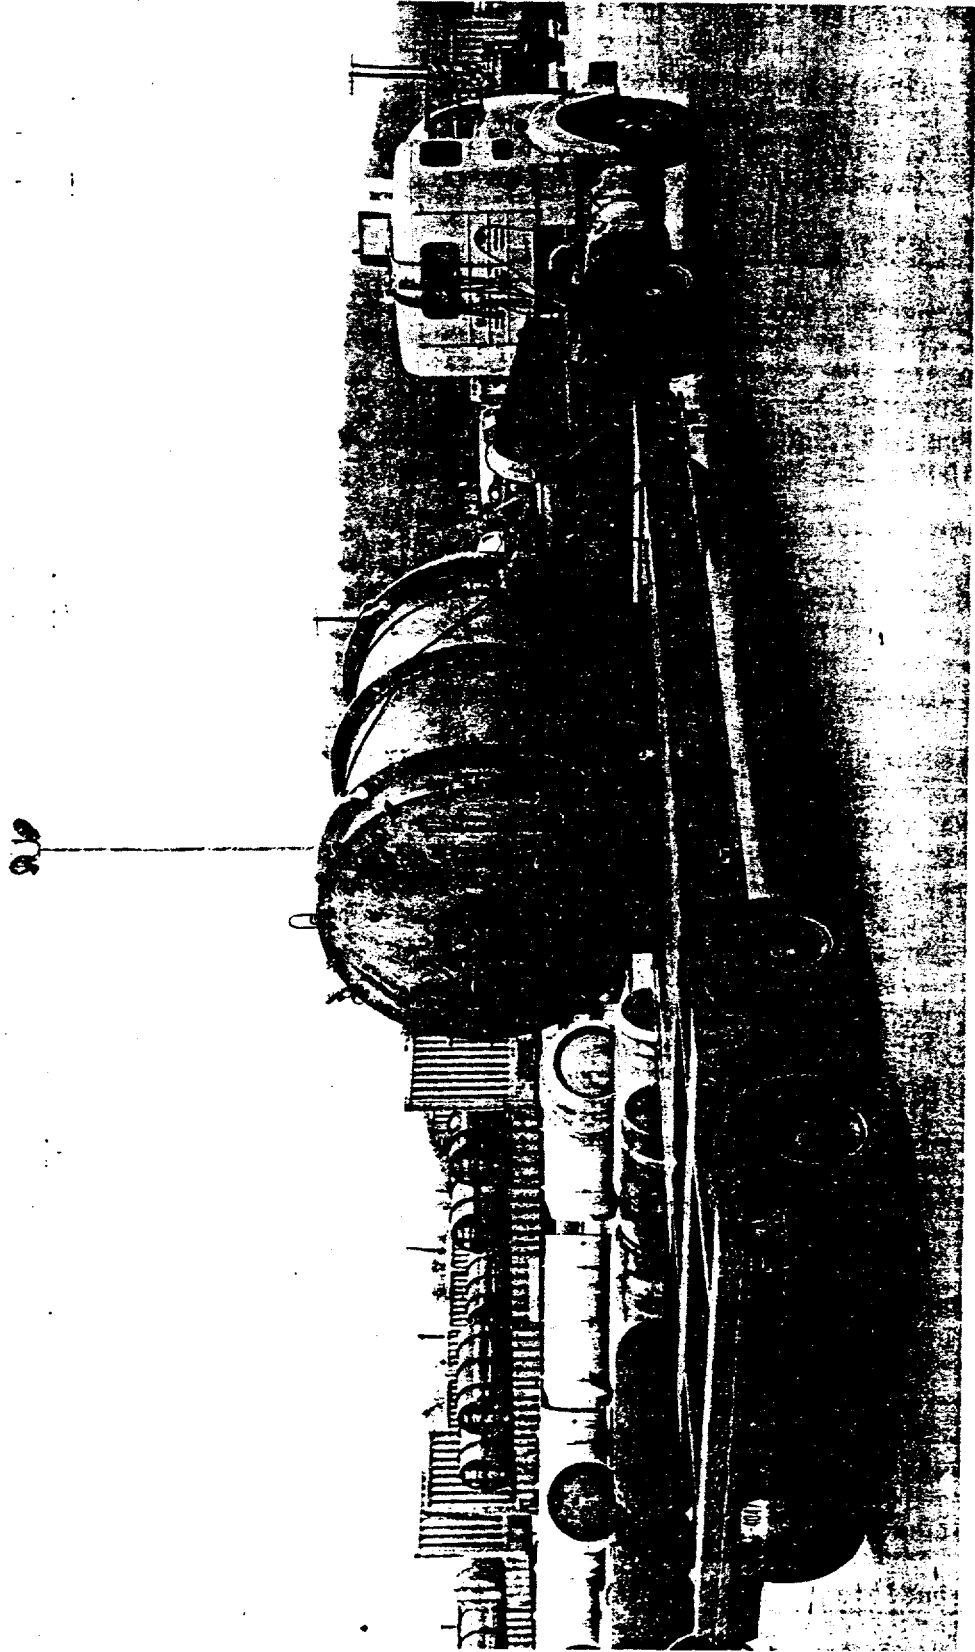
PHOTO NO. 75-3028

Figure 8
TRANSPORT OF CYLINDER ASSEMBLY TO CASCADE

Initial analytical investigation and metallurgical examination (Appendixes F and E) indicated the need to provide securement for the cylinder ends and secondary containment of cylinder contents prior to handling or transport. Steel end plates and tie rods were fabricated and installed (Figure 5). A lifting fixture was provided to handle the assembly (Figure 6) and secondary containment was provided with a modified converter shell (Figure 7). The secured cylinder was then transported to the cascade for vapor feeding of contents (Figure 8).

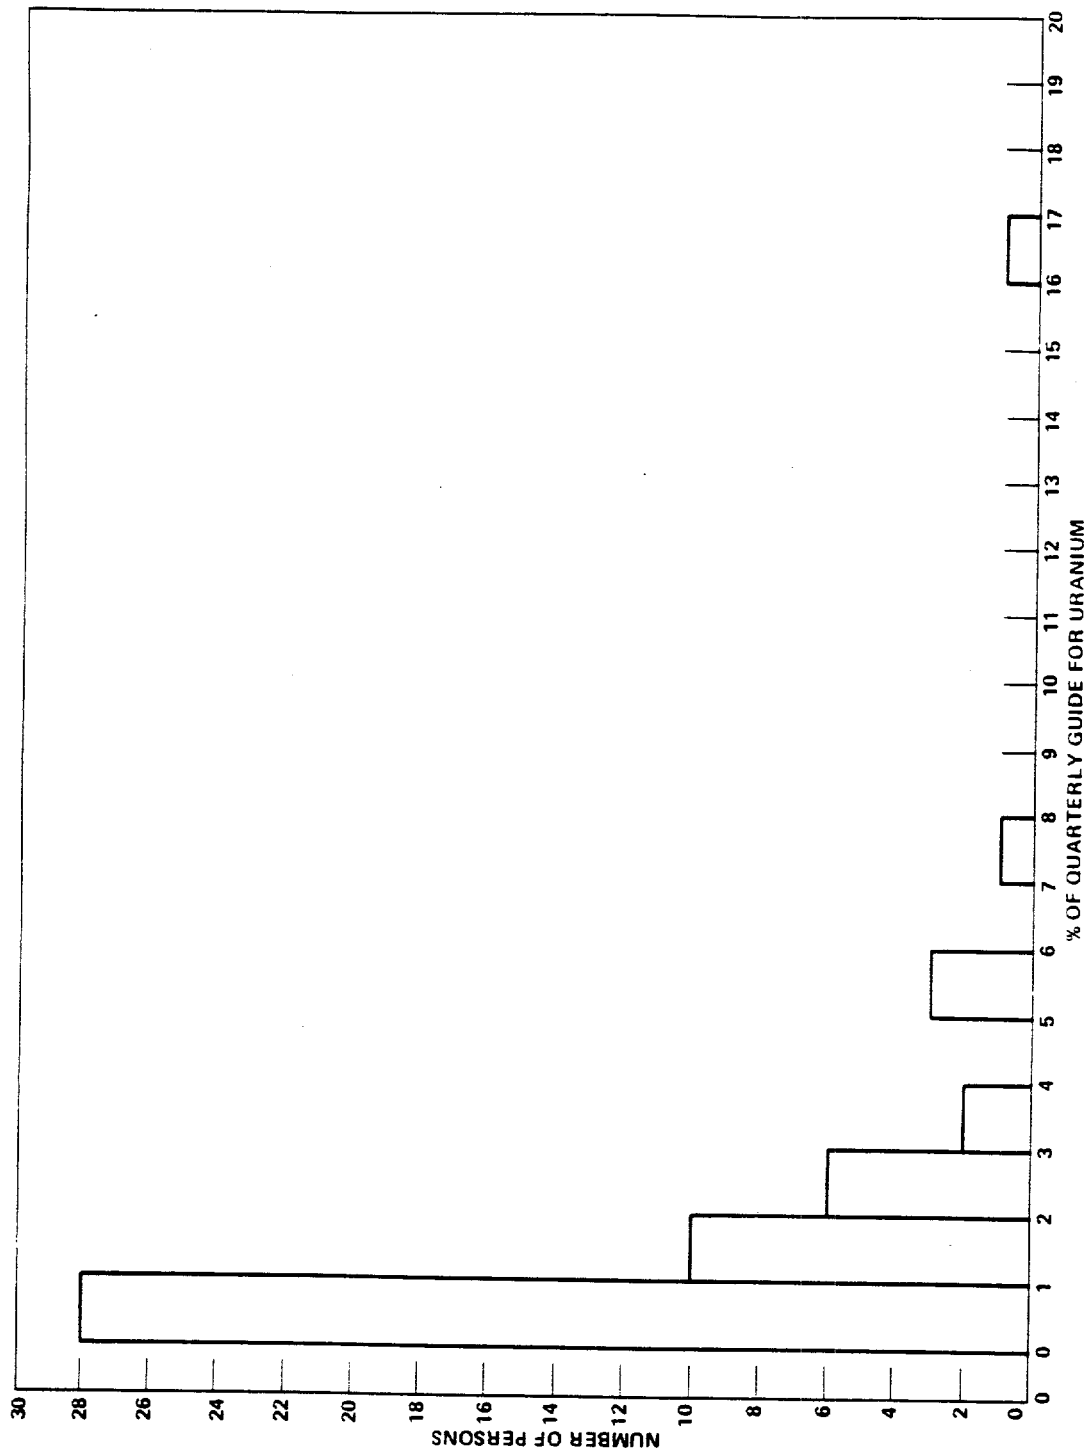
DWG. NO. G-75-895
(u)

As a precautionary measure, all persons who were recognizably subject to possible uranium inhalation submitted urine samples for analysis. Sampling involved a total of 53 persons. Indicated uranium intake for over half of these corresponded to exposure for a quarter to less than 1% of the ERDA Radiation Standard for airborne soluble uranium. The distribution of indicated exposures is shown graphically in Figure 1.

Figure 1
DISTRIBUTION OF INDICATED EXPOSURES
TOTAL PERSONS - 53

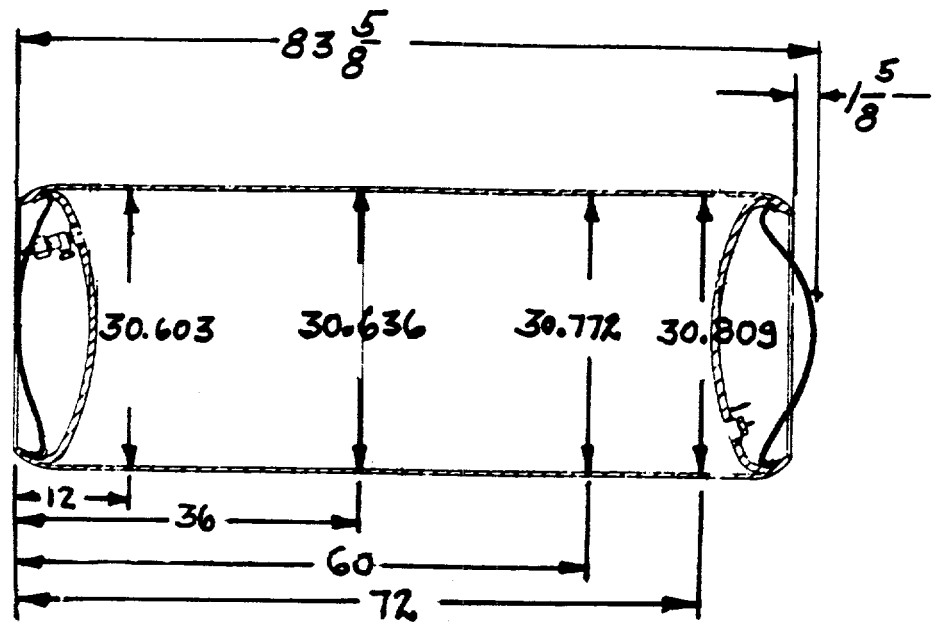
Dimensional measurements of length and diameter were taken on Nukem Cylinder No. 8 following the incident. Since there were no prior - incident dimensional data on this cylinder, a twin vessel, Nukem No. 1, was measured to provide baseline dimensional data. The dimensional results from these two cylinders are shown in Figures 7 and 8. Diameter measurements were made with a "pi" tape at the same locations on each cylinder and the overall lengths were measured with a graduated tape. The overall length of Nukem No. 8 was measured to the center of the bulged head which protruded 1 5/8 inches beyond the edge of chine on the plug end of the cylinder. The bulge on the valve end was nearly flush with the chine. The bulging of the two heads was nearly equal since the chine on the valve end was approximately 1 1/8 inches longer than on the plug end. This observation was confirmed on Nukem No. 1, on another twin Nukem cylinder, and on six other random cylinders nearby. The dimensional data indicate that cylinder Nukem No. 1 was near the drawing nominal dimensions except for the difference in chine length. Using the Nukem No. 1 as a base, the average diametrical increase of Nukem No. 8 was 0.66 inches. The length increase due to axial stretching of the cylinder wall was not directly measurable however it was estimated to be no more than 1/2 inch, assuming that the heads bulged symmetrically.

Figure 7
DIMENSIONAL DATA NUKEM NO. 8

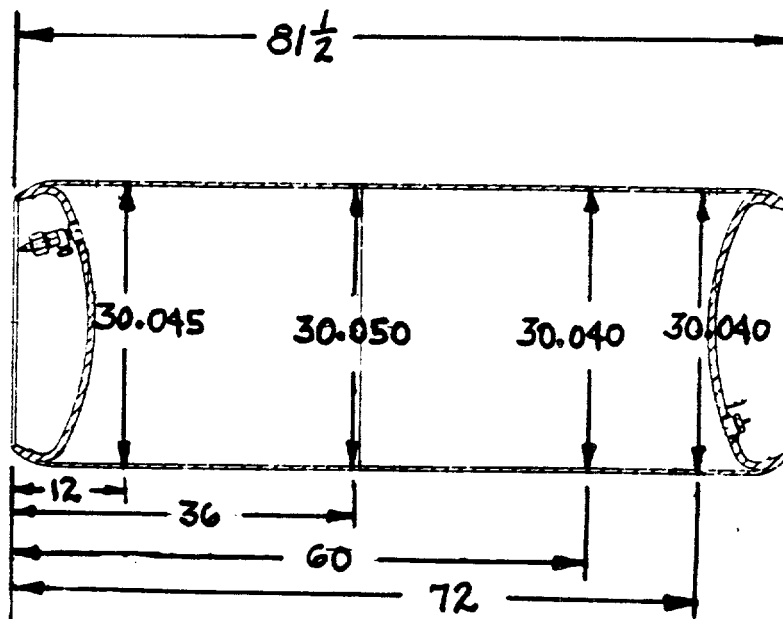
Figure 8
DIMENSIONAL DATA NUKEM NO. 1

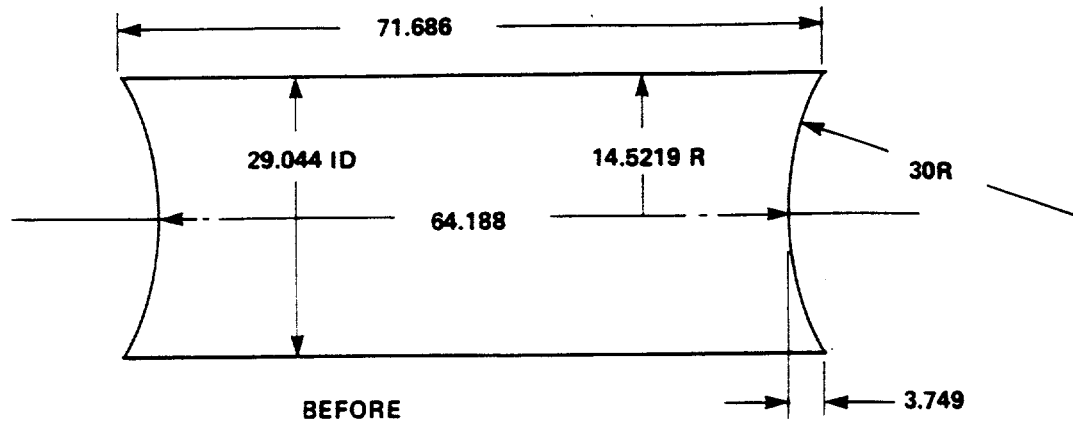
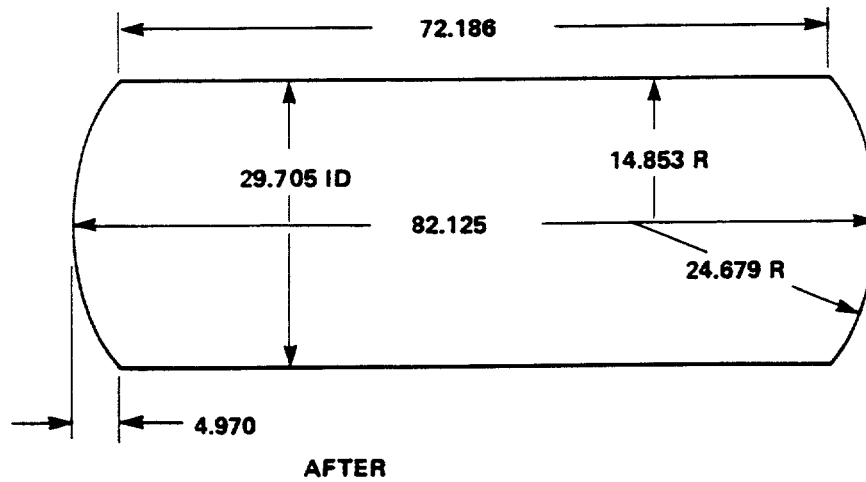
DWG. NO. G-75-897
(u)

The increase in internal volume of Nukem Cylinder No. 8 was calculated from post incident dimensional data on the incident cylinder using the dimensions of Nukem Cylinder No. 1 as a base for the estimate. For this purpose, the cylinder geometry was idealized as shown in Figure 9 and geometrical details near the joints and on the bulged heads were ignored. The cylinder interior was assumed to be bounded by a right circular cylinder with concave spherical heads before the incident and with convex spherical heads afterwards. The calculation of the initial volume is as follows:

Figure 9
IDEALIZED CYLINDER GEOMETRIES
